# **PREFABRICATED AIRFIELD AND ROAD SURFACING MEMBRANE INVESTIGATION**

**ENGINEERING TESTS, JANUARY 1956 - DECEMBER 1959**

**TECHNICAL REPORT NO. 3-492**

**U. S. Army Engineer Waterways Experiment Station  
CORPS OF ENGINEERS  
Vicksburg, Mississippi**

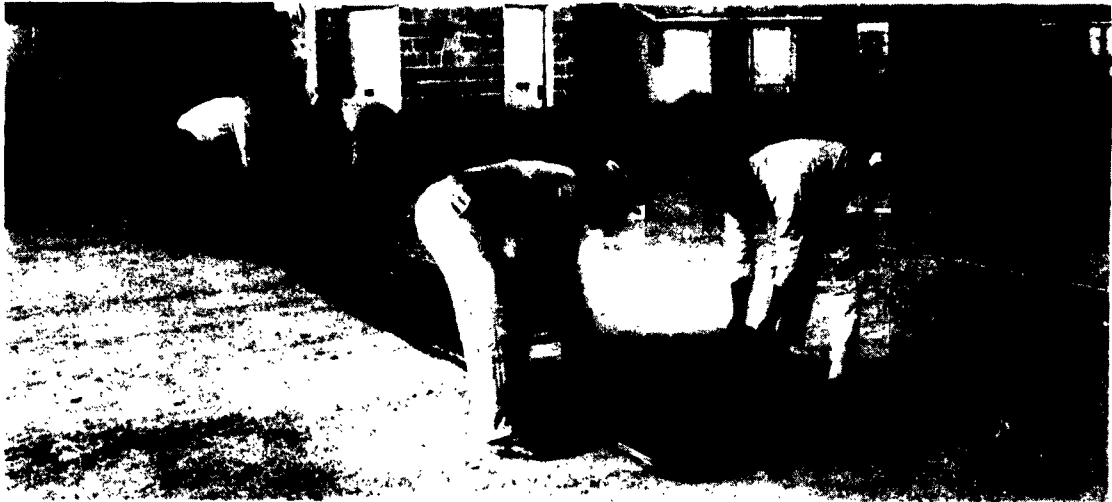
Fig. 11. Sewn membrane panel being unfolded across the test lane

27. Sewn membrane sections. Test sections 2, 4, and 6 were surfaced with sewn panels of the T1, T13, and T12 membranes, respectively. Each panel was 42 ft wide and 26 ft long and was constructed of membrane runs sewn together with a 1-1/4-in. single-lap, double-stitched joint. To surface these sections, the sewn membranes were unfolded first across the test lane and then along the lane as shown in figs. 11 and 12. To smooth the

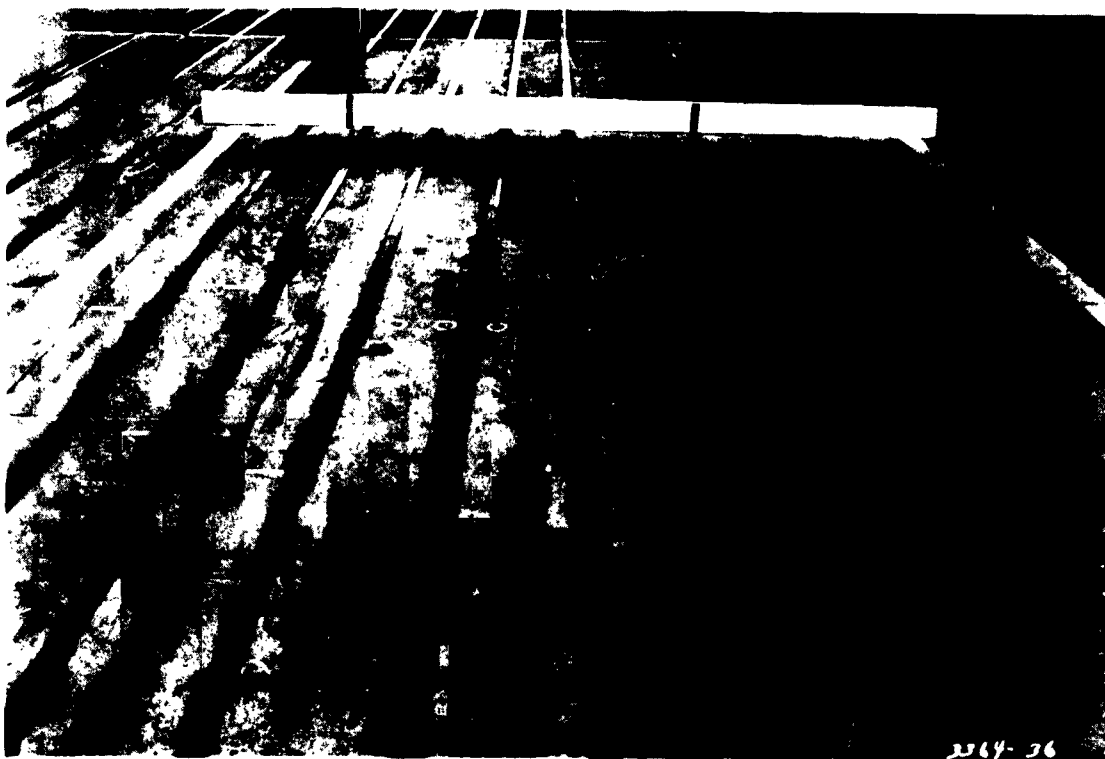
Photograph 11. Section 1, lane 1, prior to start of traffic tests

membrane, was used as the control or standard with which other sections surfaced with adhesive-bonded membranes were compared. Photograph 11 illustrates the smooth surface appearance of the section before traffic. As traffic was applied, it was observed that there was a tendency for the membrane to stretch and become slack; because of this, a slight wrinkle formed in the material in front of the load wheel as it passed over the section. However, traffic did not produce any appreciable detrimental effects on this membrane. Adhesive EC-866 used for sealing the joints was satisfactory except in a small area which became unsealed at 40 coverages (fig. 17); this was a result of failure to clean the membrane surfaces properly at the time adhesive was applied. The affected area was cleaned and resealed with adhesive EC-866 which provided adequate bond for the duration of the traffic tests. After 350 coverages, traffic was discontinued as there were no indications of membrane deterioration or subgrade failure (photograph 12). As shown in table 3, the CBR of the section varied from 42 at the start of traffic to a high of 60 after 174 coverages; the CBR at the end of the test

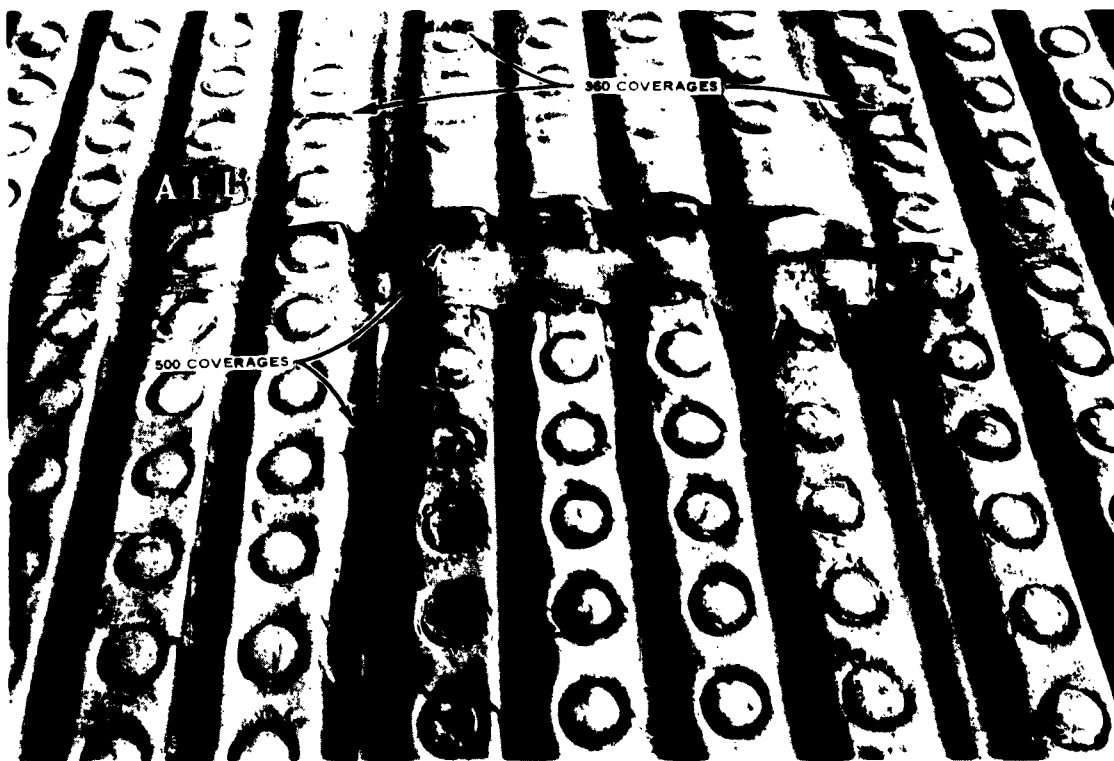
Photograph 24. Section A, lane 2. Note failures of T1 cotton duck membrane caused by tubular holes (360 coverages) and end of mat panel (500 coverages)

occurred near an end joint of the mat (photograph 24). The membrane failure was repaired, damaged mat panels were replaced, and traffic was continued. After 700 coverages, the riding surface of the section was smooth, even though end curl of the overlapping panels amounted to approximately  $3/4$  in. (photograph 25). Photograph 26 shows typical breaks in the mat after 700 coverages. (The soil on the mat surface was carried onto the test section by the load wheel from the soil bumper which was constructed

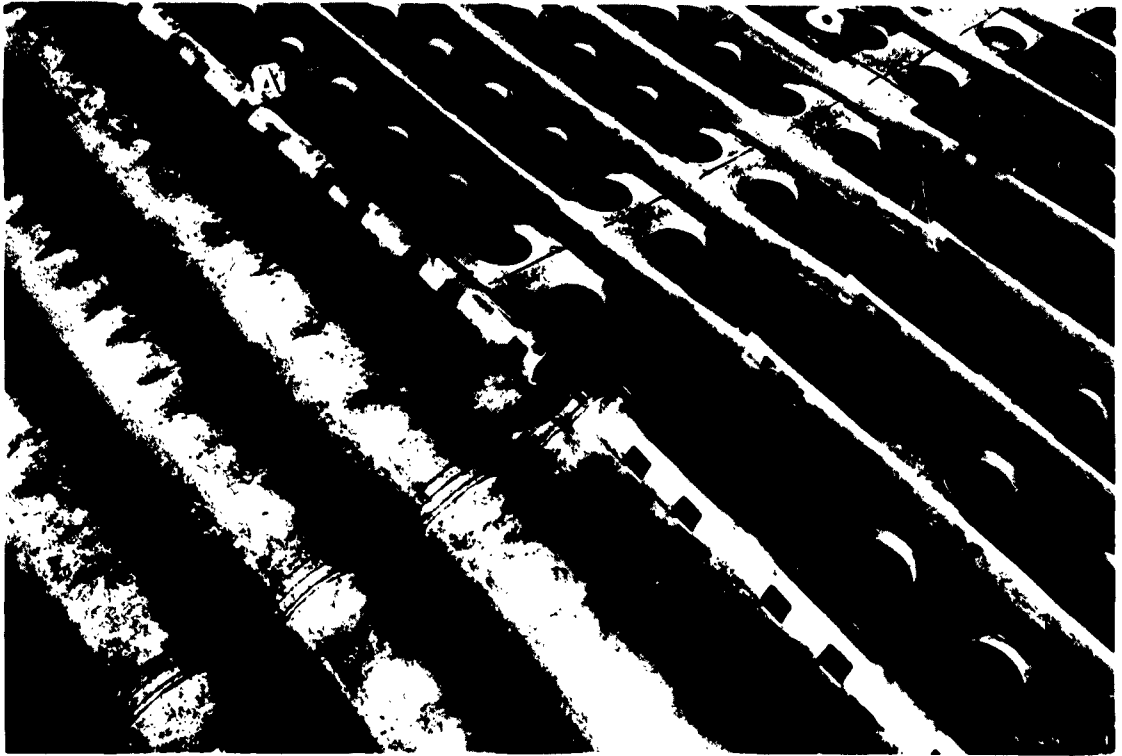
Photograph 27. Failure of T1 membrane caused by rolled edge of mat after 700 coverages on section A, lane 2

at the end of the test lane for safety purposes.) After the mat panels were removed from the section, numerous small cuts were found in the membrane; these had been caused by the rolled edge of the mat near the panel end joints (photograph 27). Sewn and adhesive membrane joints remained in excellent condition, although the thread of the sewn joints had been severely scuffed and abraded by the flexing of the landing mat. After 700 coverages, the mat in the traffic lane was approximately 70 percent seated.

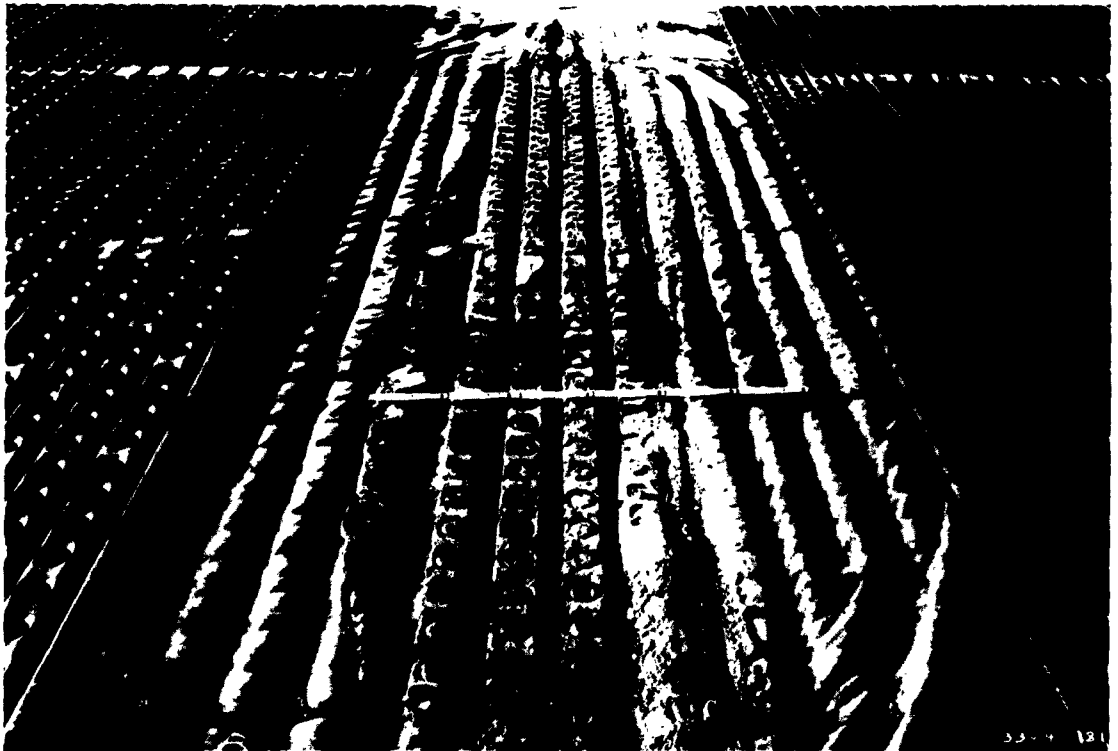
Photograph 30. Separation of membrane surfacing on lane 2 caused by failure of transition joint between sections B and C

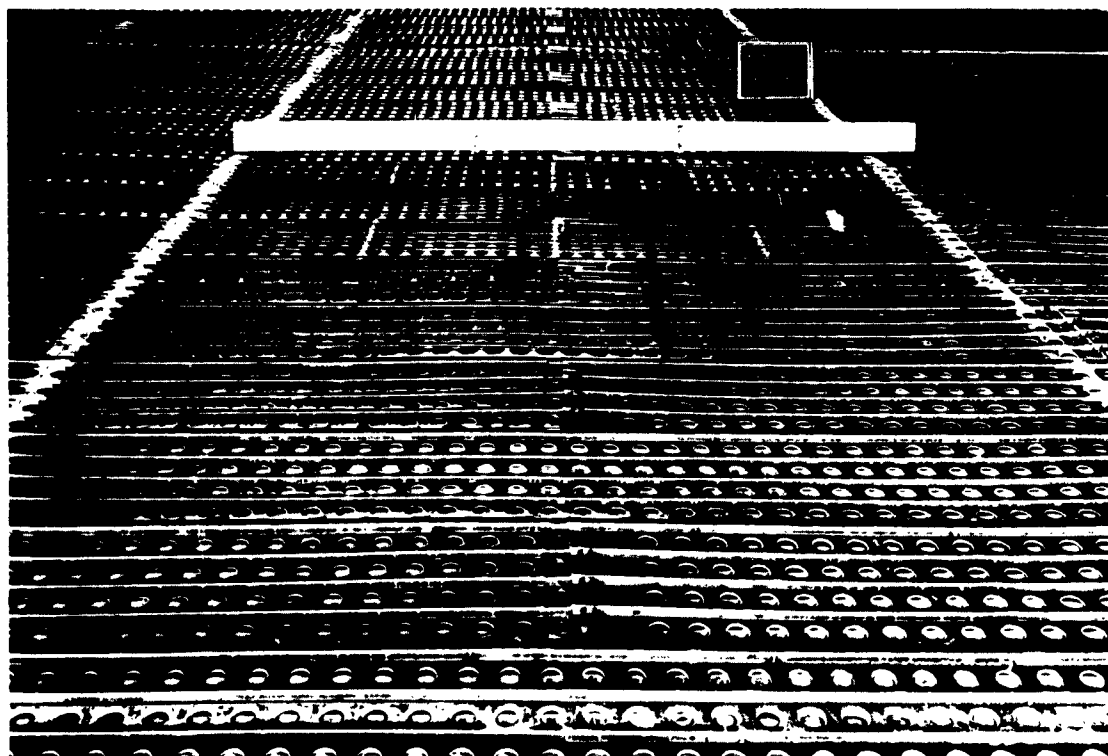
Photograph 31. Section B, lane 2, after 700 coverages

developed in the M8 mat after 500 coverages, and that considerable scuffing of the membrane surface by the tubular holes of the mat had occurred as the mat flexed under the test wheel. Several cuts found in the membrane surface near the panel end joints were caused by the rolled edge of the mat. Adhesive and sewn joints remained intact, even though the ribs of the mat had scuffed and abraded the threads of the sewn joints. The membrane area which had been patched after 350 coverages remained sealed. The riding surface of section B remained smooth after 700 coverages as no appreciable panel end curl or mat deformation had occurred (photograph 31). Small breaks had developed in several mat panels in the traffic lane, but were not considered failures as traffic could have continued. The surface of the membrane had sustained considerable scuffing from the tubular holes of the landing mat, and the vinyl coating had been removed from the top side of the fabric. However, since the fabric was coated on each side, water had not seeped into the subgrade. Several membrane punctures had occurred beneath the end of the rolled edge of the mat panel near the end joints. These punctures were caused by the rolled edge of the mat panel which moved back and forth across the membrane surface as the load wheel traversed the section, producing a knifelike cutting action and causing the punctures shown in photograph 32. All sewn and adhesive joints remained sealed, and measurements revealed that the mat in the traffic lane was approximately 50 percent seated.

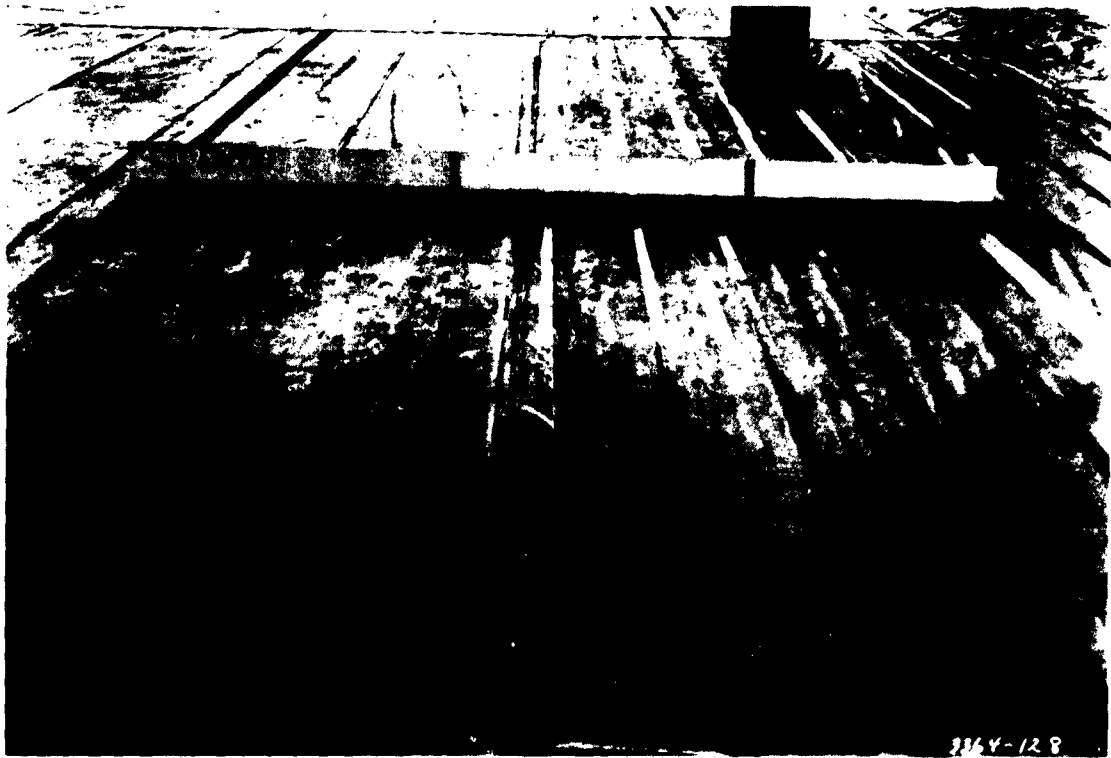
Photograph 37. Section E, lane 2, prior to start of traffic tests

50. Sections D, E, and F. The T14, T12, and T13 nylon membranes were used to surface sections D, E, and F, respectively. Photographs 35, 37, and 39 show the relatively wrinkle-free surfaces of these sections prior to traffic tests. As the load wheel traversed each section, a slight roll formed immediately in front and to the sides of the wheel. Nevertheless, the riding surface of each section remained smooth, and accelerated traffic produced no failures in the membrane surfaces. The sections were inspected at 40, 176, 280, 350, 500, and 700 coverages. These inspections revealed that the membrane surfaces and joints (sewn and adhesive) were intact and waterproof. Photographs 36, 38, and 40 show the membrane surfaces of sections D, E, and F after 700 coverages. The patch shown in photograph 40 covers a hole which had been cut in the membrane surface of section F for inspection of the subgrade after 350 coverages.

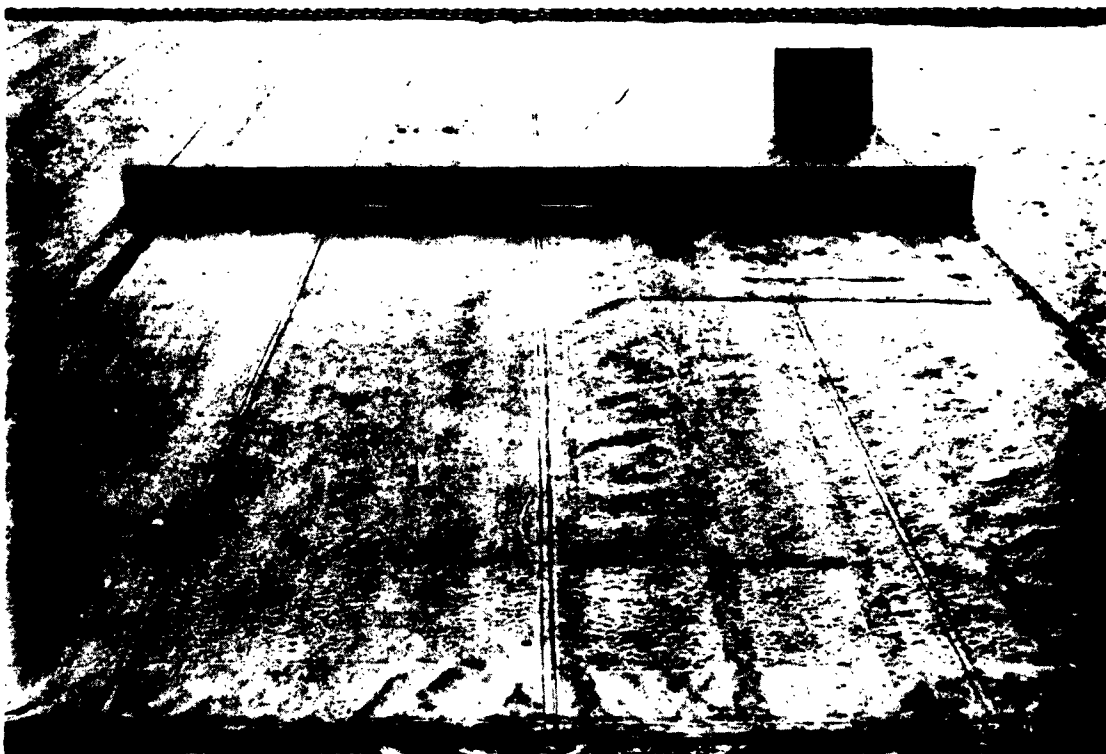
Photograph 42. Section G, lane 2, after 700 coverages

51. Section G. The T1 membrane which surfaced section G presented a smooth surface appearance before traffic tests (photograph 41). Inspections at 40, 176, 280, and 500 coverages revealed that the section was waterproof and relatively unaffected by the traffic. After 700 coverages, most of the section remained intact (photograph 42); however, one small hole had developed in the membrane, as shown in fig. 20. This hole was caused by a piece of gravel which was forced through the membrane by the load wheel. In normal field or user tests, this small hole would not constitute a major failure as it could be swiftly repaired by patching.
